Machine shop motor failures

Application Note

Power Quality **Case Study**

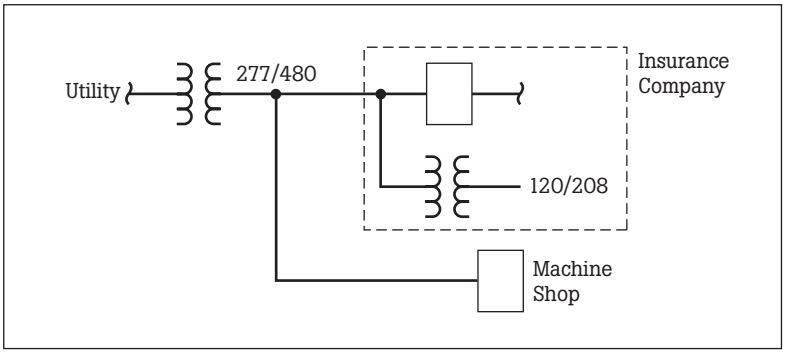
The machine shop itself hadn't undergone any changes. But an insurance company had moved into a new building next door. And they had done so at about the time when the motor failures began. The same utility transformer supplied both buildings (see Fig. 1).

Fig. 1 Utility connections for the machine shop and insurance company

the voltage waveform was flat-topped, with a total harmonic distortion (THD) of 7.8 %. It's significant to note that the 5th harmonic was the dominant bar on the harmonics display — a fact key to the analysis of the problem.

In the case of the machine shop, non-linear loads in the neighboring insurance building caused 5th harmonic distortion on the supply voltage. Computer and office machine loads connected to the 120 V receptacles were generating 3rd, 5th, 7th, 9th, and 11th harmonic currents. When these currents reached the 120/208 V transformer, the balanced portion of the zero sequence harmonics (e.g., 3rd, 9th) were trapped in the delta primary but the 5th, 7th, and 11th passed through. These reached the secondary of the utility transformer, where they caused the voltage distortion measured at the machine shop service.

The utility, when notified about the voltage distortion problem, agreed to install a separate transformer serving only the machine shop. The Fluke 43B showed voltage distortion on the new transformer was only 3.3 % — less than half of the previous value.
